JEREMY BULL saves
a model that fell on
hard times

Elizabeth Morag

A Vintage Steam Yacht Restoration

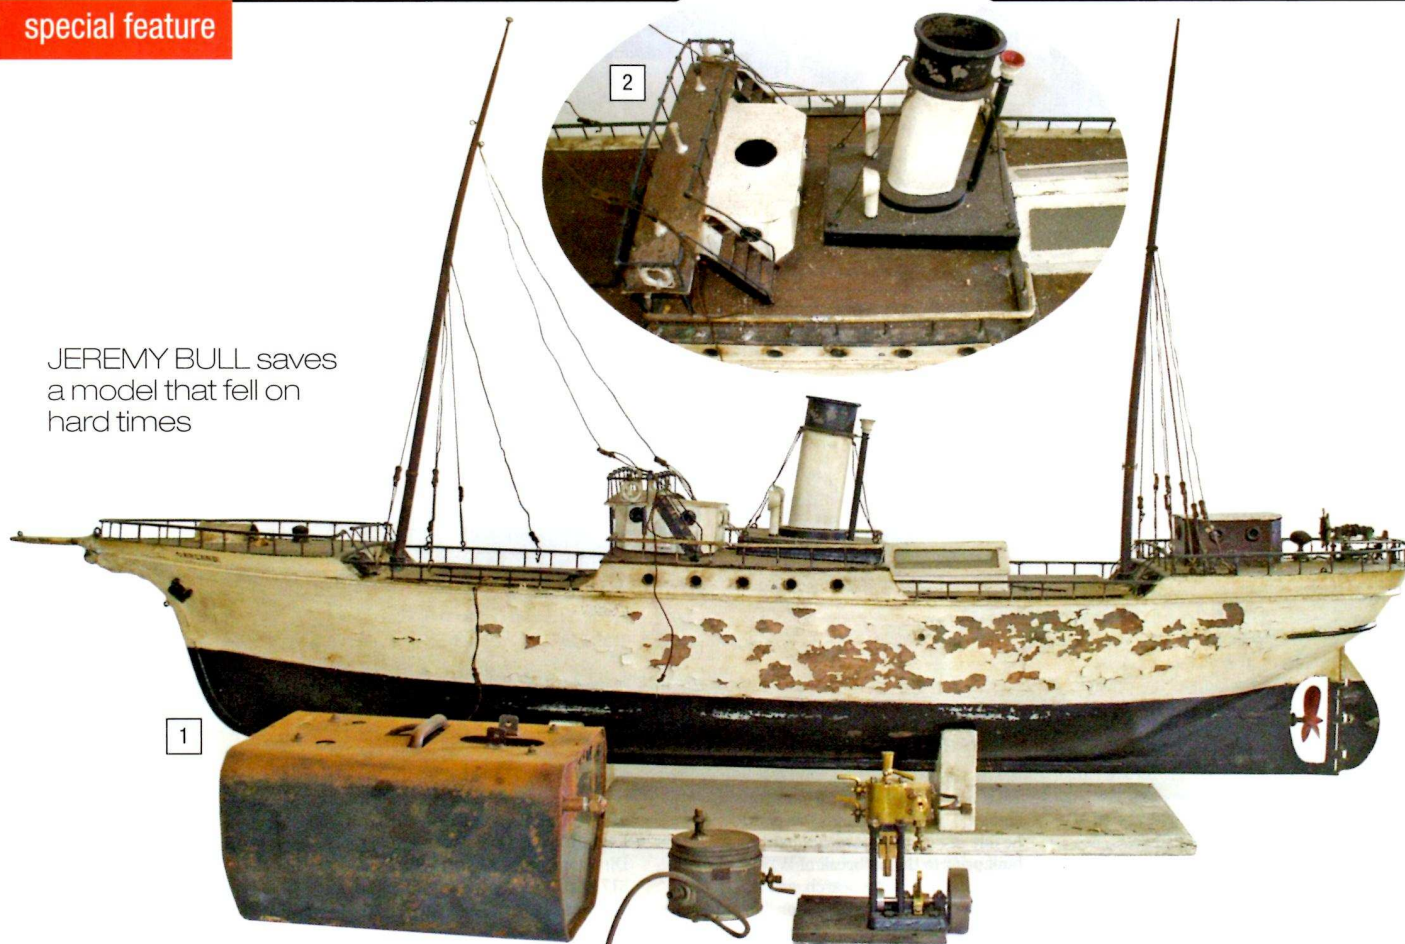
This is the story of a fine model that had fallen on hard times, **Photo 1**. Originally named *Garland* as far as I can tell, it was rescued from years of sitting on a shelf in someone's garage and was essentially complete, but incapable of being steamed. **Photo 2** is a close-up of the centre section and funnel and **Photo 3** is of the stern and poop deck. Peering into

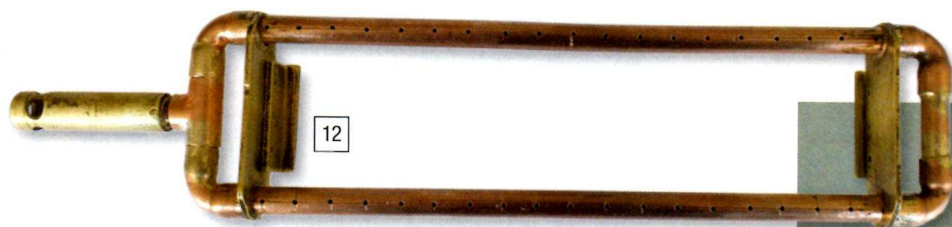
Photo 12. The final diameter of the poker holes was determined by testing with the boiler. These were eventually optimised at 1.9mm diameter which gives sufficient 'oomph' to maintain pressure at about 30 to 35psi with the engine running at a speed to realistically propel the yacht, but without wasting steam and gas by 'blowing off'. However, it must be said that the final hole size was determined after practical on the water steaming trials subsequent to this last picture.

For this, I decided that gas would be the cleanest solution. A double poker type was designed and made using small bore central heating fittings and tubing for the poker, whilst I made the gas jet and mixing tube,

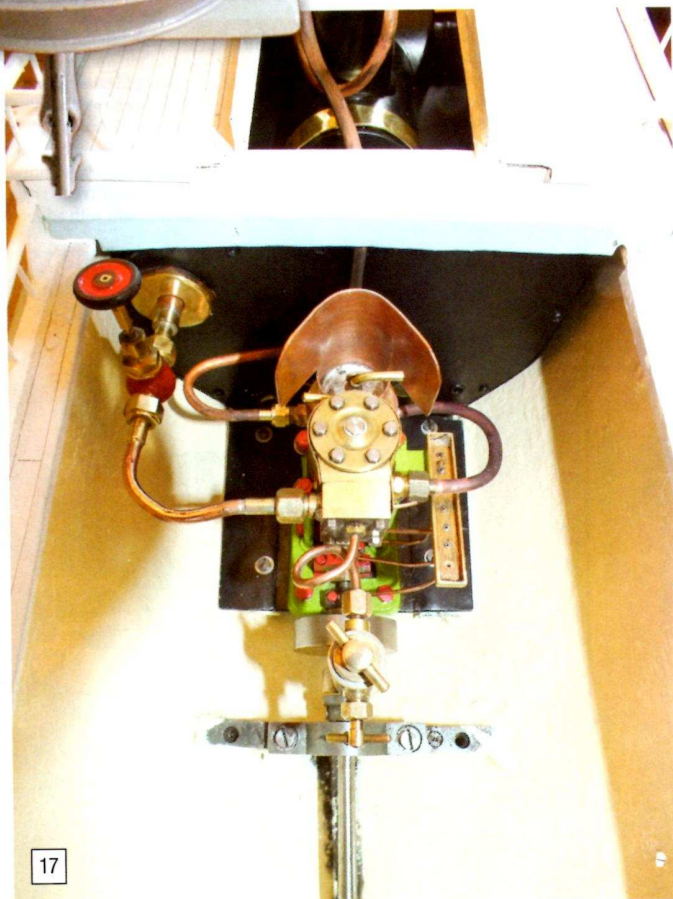
17

With the upperworks completed, the boiler and steam engine could be re-inserted into the hull and plumbed, **Photo 17**. As you can see, the twin drum boiler and its casing is a tight squeeze and is, I should imagine, not the original 'as built' unit. Additional work included constructing an oil and water trap and piping the exhaust up the funnel. The safety valve was also piped to expel via a tube behind the funnel. This looks more realistic than having excess steam roaring out through open portholes giving the impression of a major boiler catastrophe or a medieval dragon! Bezels were also made to tidy up the holes around the pressure gauge and the main throttle valve where they projected through the deckhouse and deck respectively as was shown earlier (please see Photo 10 again).
