# You have one new

**Jeremy Bull**  
describes the  
restoration of *Ellise*

# email...

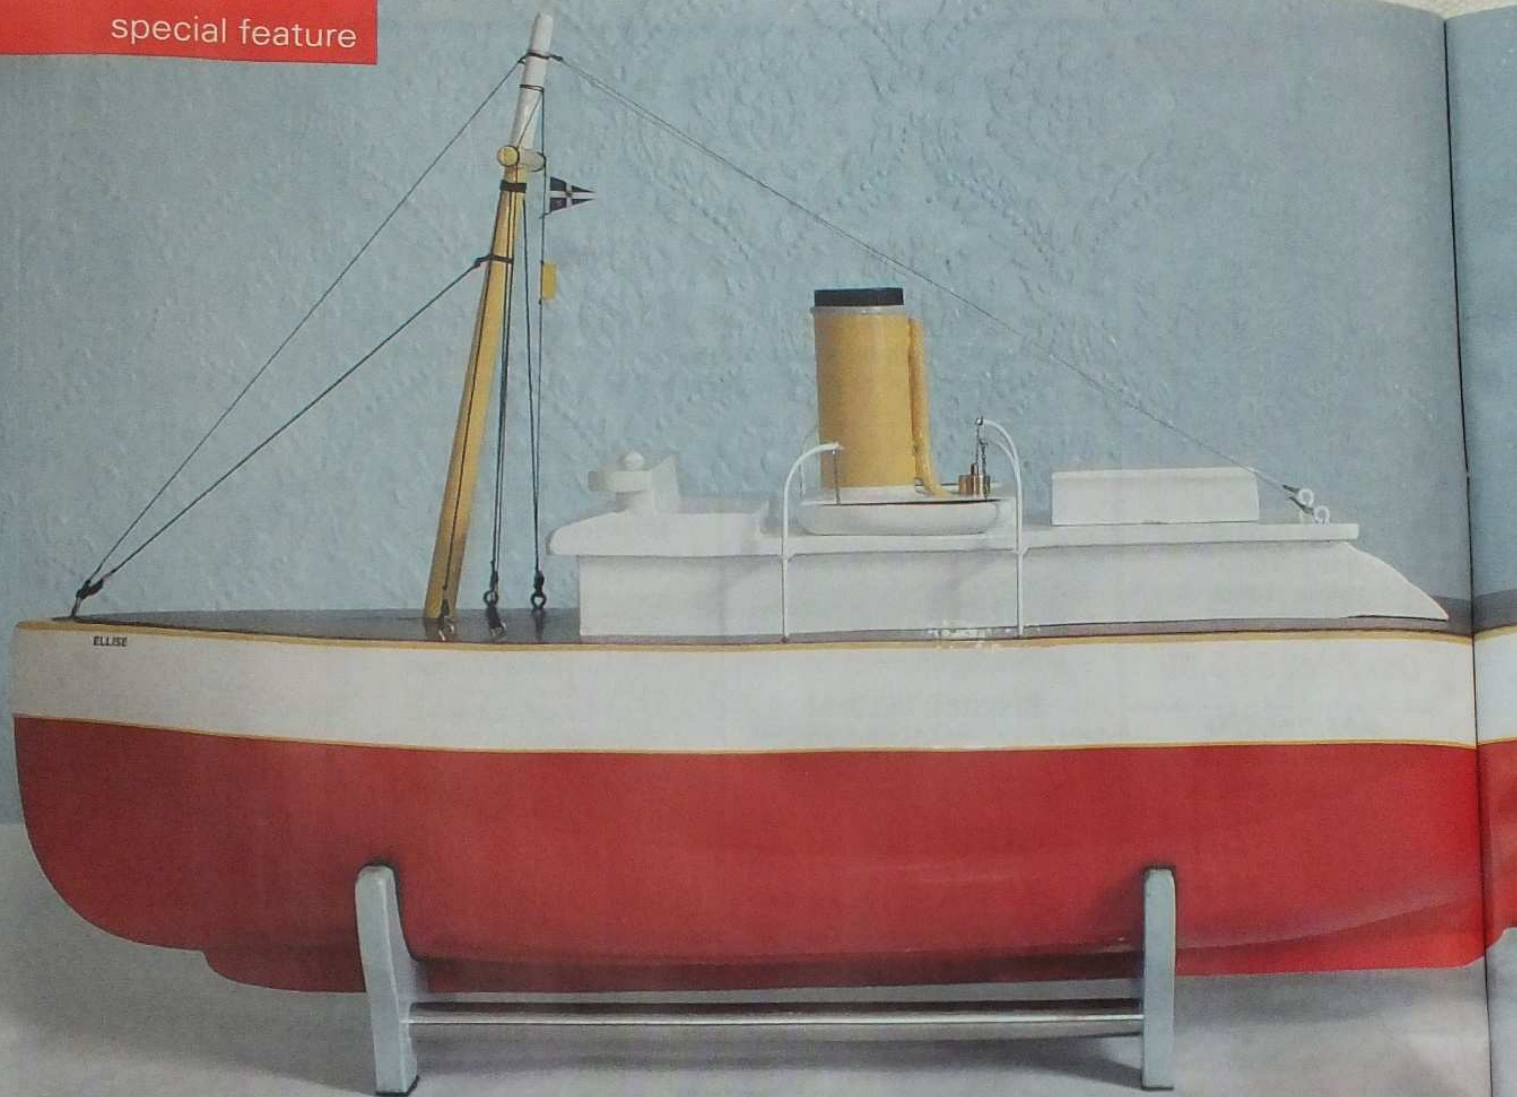
The email was from Les' Spence, and so my involvement started with a rather nice, but tired steam powered model boat. **Photo 1** is the emailed picture of the model and how it actually was when received.

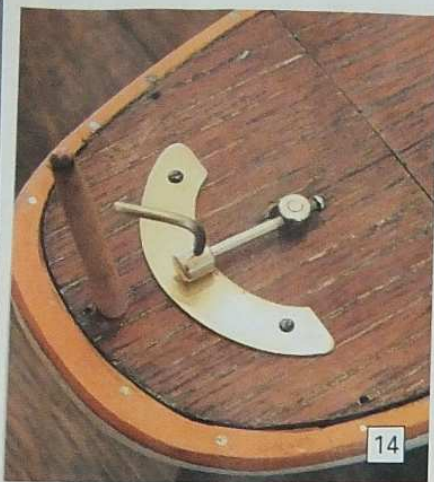
By now I should have learnt my lesson from previous restoration projects, as the rudder post was not vertical and the tiller arm scribed an off-

centre half circle and worse than that, when turned to port it was up in the air and to starboard it wanted to be 1/8 inch (3mm) below deck. So, this was now looking a bit like the previous restoration of Joanne of Kyle all over again.

So, off came the rudder and out came its tube. The resulting hole through the hull was opened out sufficiently to get the new rudder tube vertical in all its planes. The rudder shoe was reattached to the bottom of the hull and a long length of round straight steel of the internal diameter of the rudder tube was inserted into the tube and located into the hole in the shoe where the rudder stock would fit, **Photo 12**.
