Joanne of Kyle

Jeremy Bull restores an owner's model

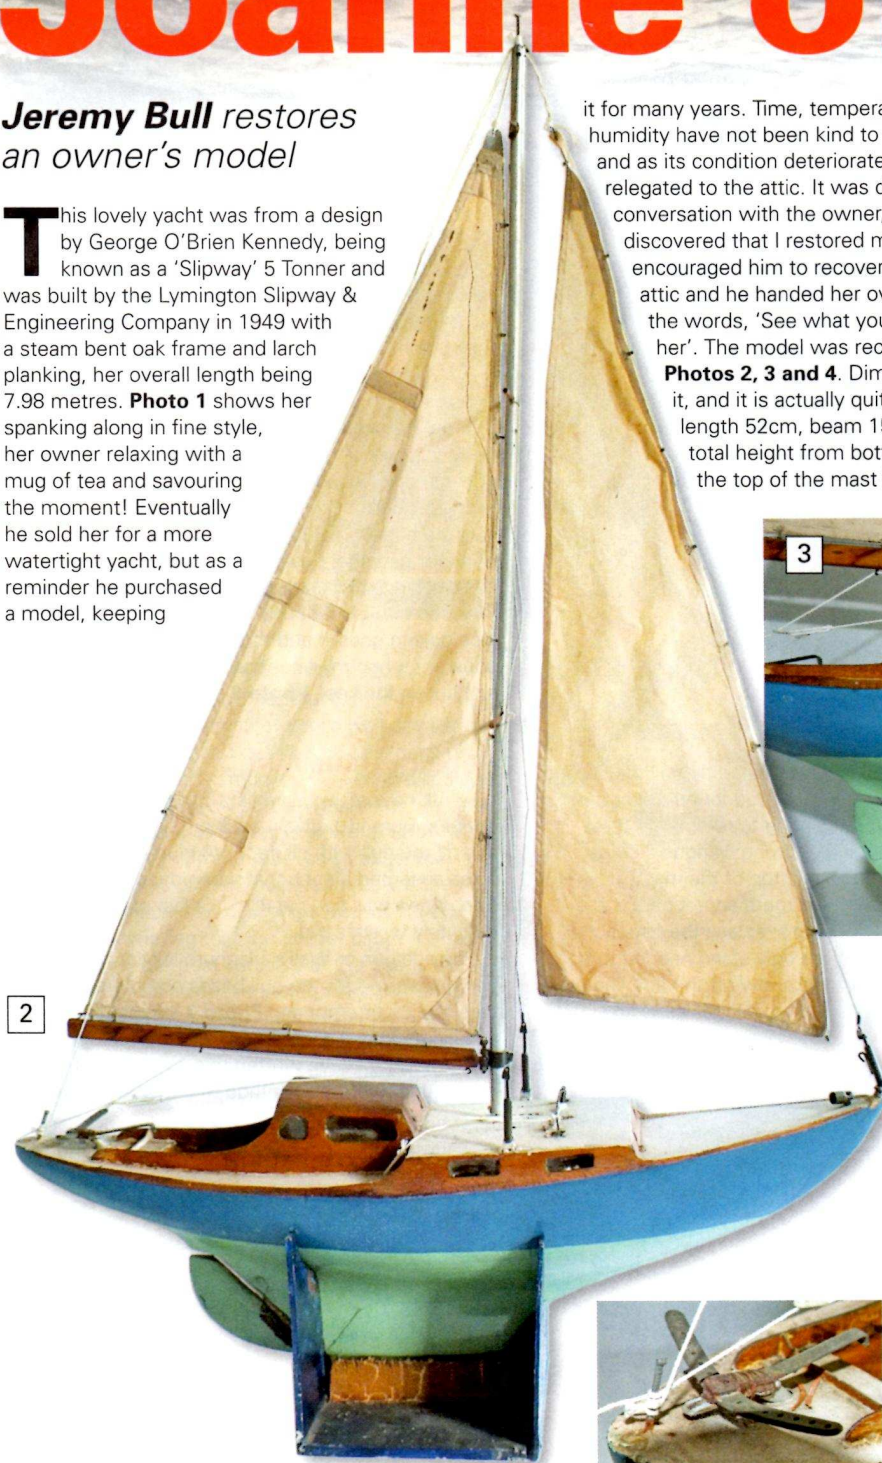
PHOTO 4. As you can see, it was originally intended to be a free-sailing model with a basic form of sail/steering control.

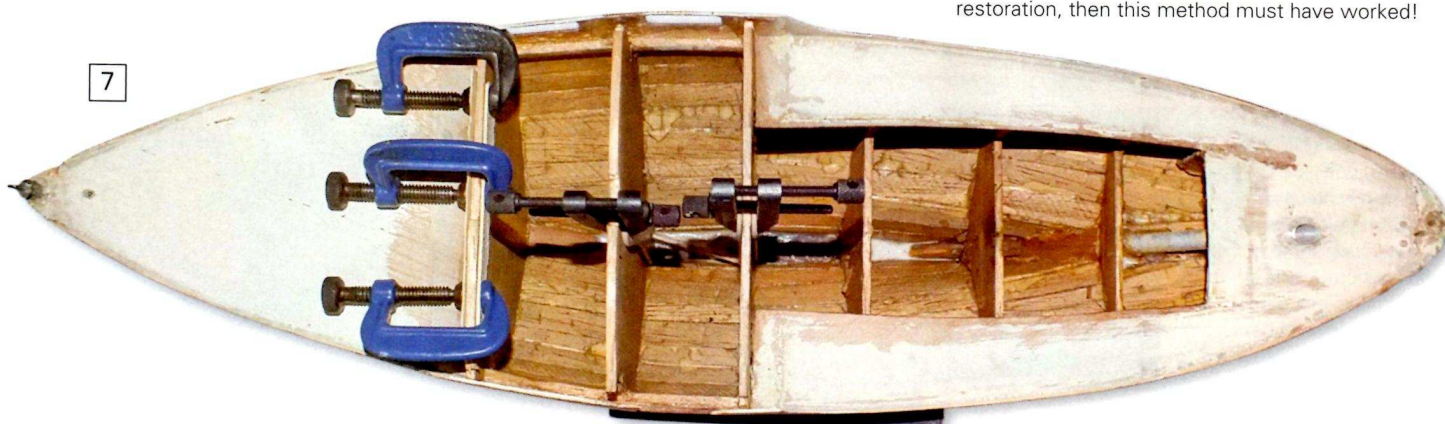
7

PHOTO 7. The hull was flooded internally with thinned glue to penetrate the wood. Strengtheners were also added to the frames.

All work now stopped whilst I considered the options. Burn it(!), give it back or take a long shot and fill the hull with diluted PVA glue and hope the balsa absorbed it such that when dried it would strengthen it all sufficiently. This last option was definitely worth a go!

The addition of Wall's Magnum lolly sticks as vertical bracing for the bulkheads completed the stabilisation attempt and **Photo 7** shows the soaked and clamped hull drying. You will have realised by now, since I have written this article about the restoration, then this method must have worked!

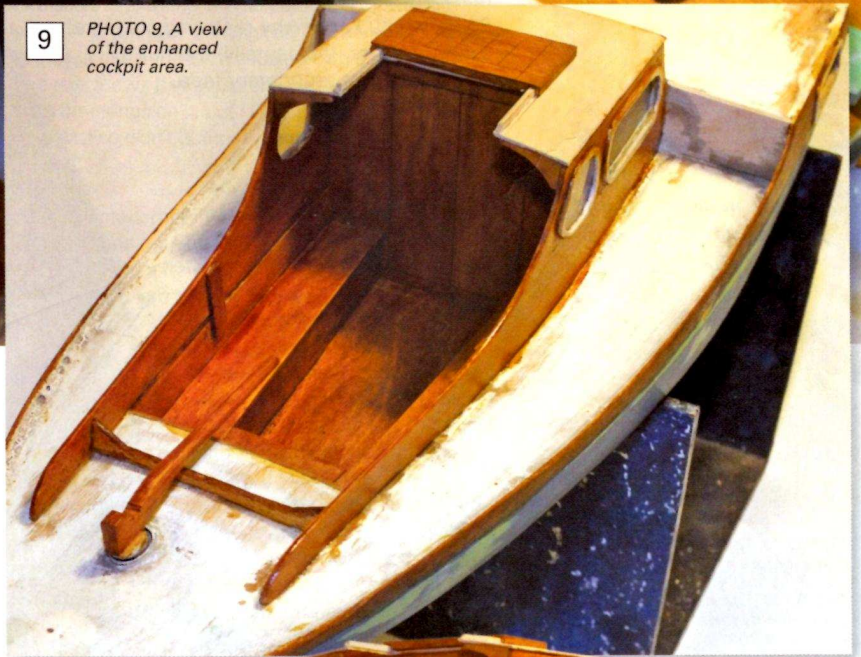
9 PHOTO 9. A view of the enhanced cockpit area.

A regular mug of fresh tea was an essential ingredient to this project, helping to reduce the 'cussing' as each new challenge was identified, such as discovering that the builder didn't locate the rudder post centrally at the stern. The opportunity was also taken to add extra detail to the cockpit area such as bench seats, window frames and a sliding hatch, **Photo 9**. Glazing for the cabin came from an old clear plastic A4 wallet and to prevent them from being pushed in again, they were not only glued to the cabin wall but additionally secured on the inside with an overlapping ply frame.

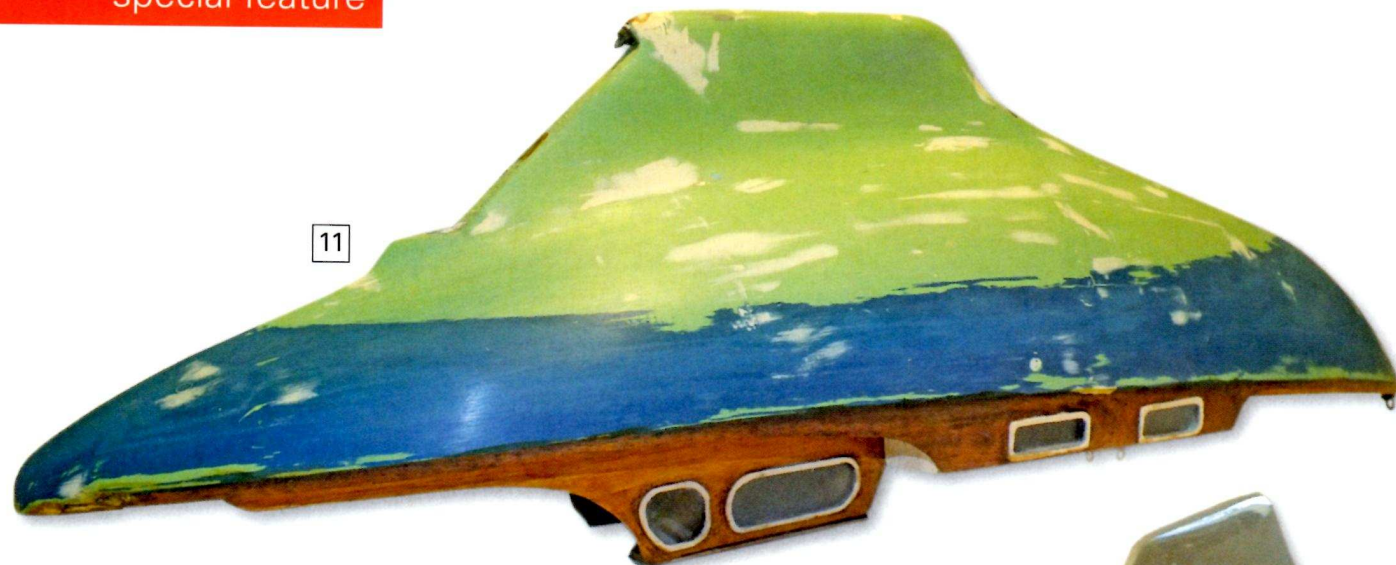
PHOTO 11. Nearly there!

until a good base finish is achieved, **Photo 11**. So, after three coats of undercoat and much filling, a final light rub-down and two coats of gloss white, it was then left for seven days before a further final very light rub down with very fine sandpaper and a last coat of gloss white, **Photo 12**. Nothing then happened for ten days (and nights) to allow the paint to become thoroughly hard before masking-off and painting the bottom in gloss red. So, now you know why restoring old paintings can take years. Incidentally, the hull's trimlines are of proprietary tape.
