JEREMY BULL saves
a model that fell on
hard times

Elizabeth Morag

A Vintage Steam Yacht Restoration

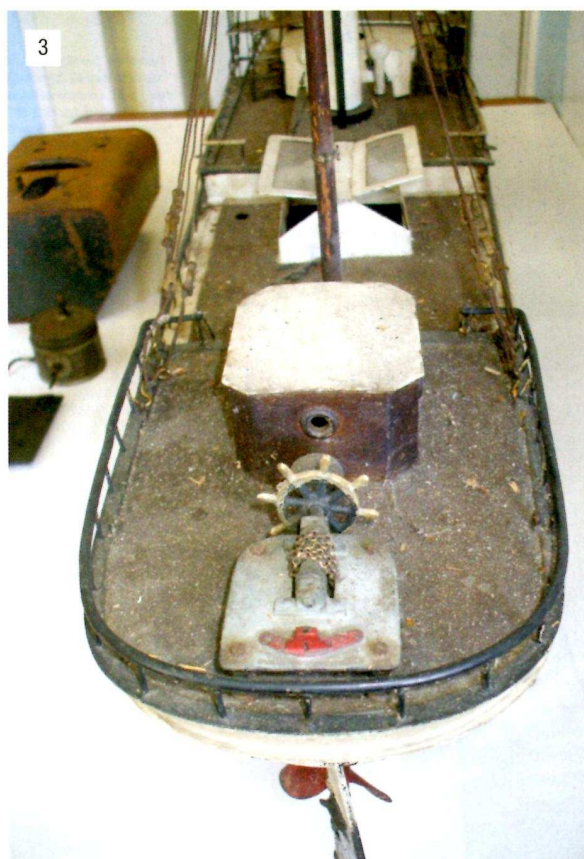
This is the story of a fine model that had fallen on hard times, **Photo 1**. Originally named *Garland* as far as I can tell, it was rescued from years of sitting on a shelf in someone's garage and was essentially complete, but incapable of being steamed. **Photo 2** is a close-up of the centre section and funnel and **Photo 3** is of the stern and poop deck. Peering into

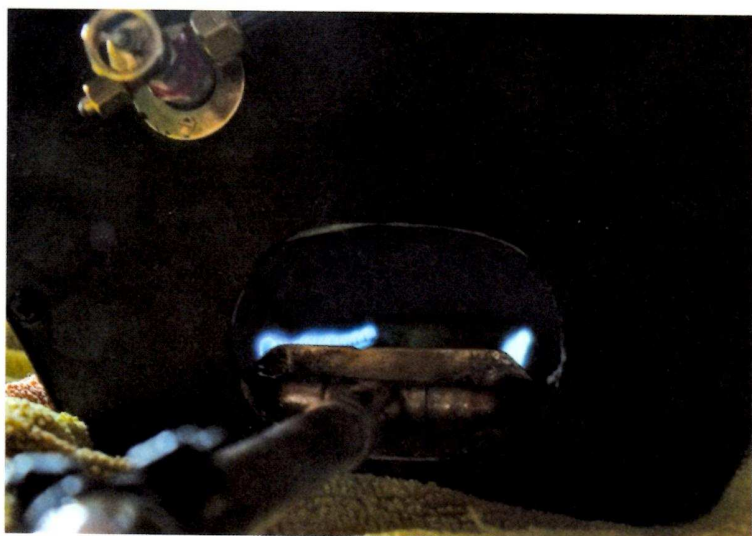
For this, I decided that gas would be the cleanest solution. A double poker type was designed and made using small bore central heating fittings and tubing for the poker, whilst I made the gas jet and mixing tube,

Photo 12. The final diameter of the poker holes was determined by testing with the boiler. These were eventually optimised at 1.9mm diameter which gives sufficient 'oomph' to maintain pressure at about 30 to 35psi with the engine running at a speed to realistically propel the yacht, but without wasting steam and gas by 'blowing off'. However, it must be said that the final hole size was determined after practical on the water steaming trials subsequent to this last picture.

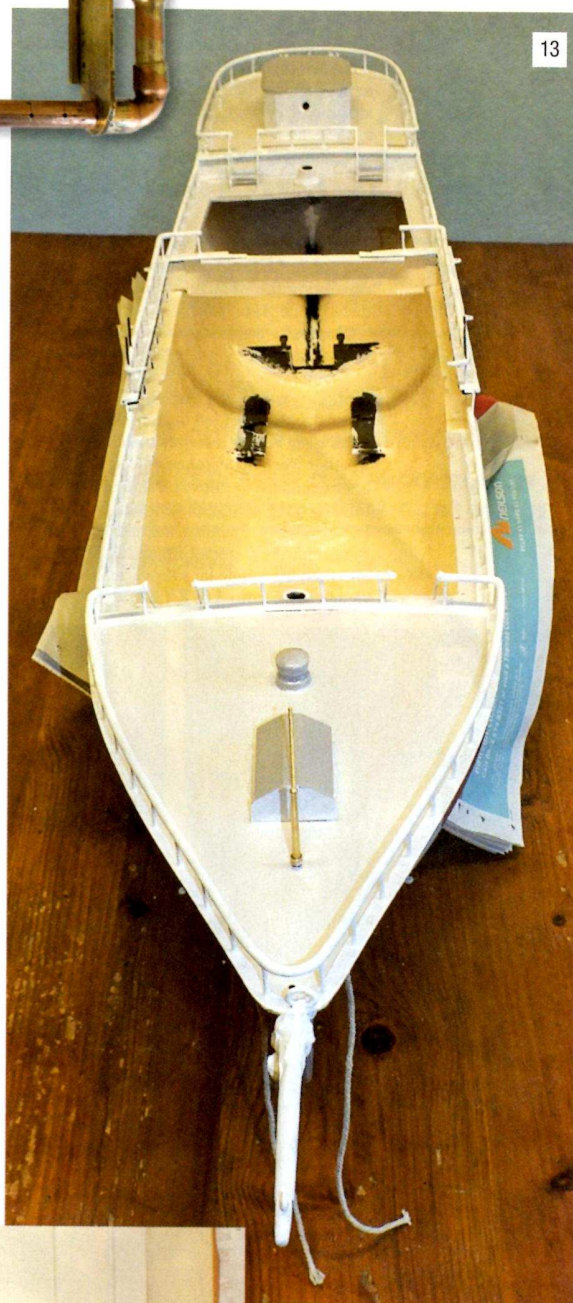
The hull's interior was also thoroughly cleaned and painted as in **Photo 13**. A nicely painted inside of a model boat hull looks so much better than it just being left bare and unpainted.

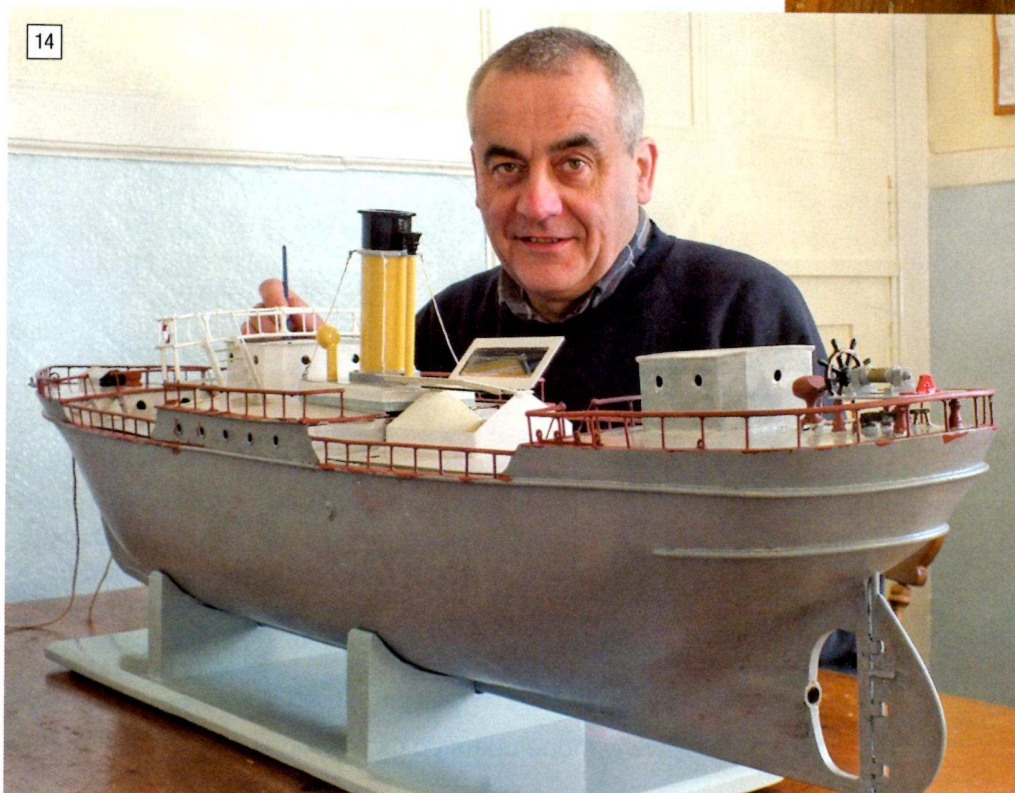
The hull exterior was initially painted with an etch primer from Phoenix Precision Paints and then undercoated and finally top coated with ICI Dulux gloss paint. About a fortnight was given for the paint to harden off fully before the hull was turned upright and placed back on its stand, **Photo 14**.
